# Alert

| <b>Outline the Scene</b> | <b>Incident</b> | <b>Cast Iron Lid Dropped During Lifting Operations – Near Miss</b> |
| | <b>Subject</b> | CR03 - Failure of Lifting Operations |
| | <b>Business Unit</b> | Fletcher Living – Canterbury |

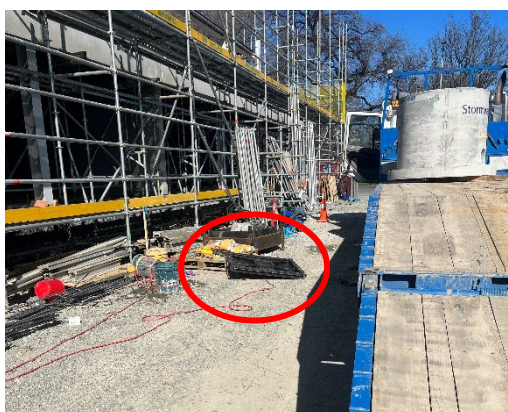
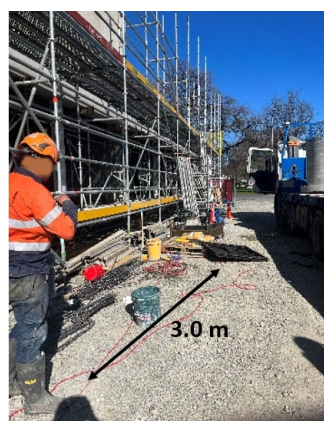
During the lifting operation of a precast unit and cast-iron lid using an excavator. There was a failure in the lifting methodology which caused the load to become unbalanced, this resulted in the cast iron lid to fall off the load.

An exclusion zone had not been established and the lid landed in an area where workers had been previously working to mix material. Fortunately, during the incident no workers were mixing however one was positioned approximately 3.0 - meters away and a rigger was positioned on the truck deck so there was potential for workers to be in the line of fire.

- Was a Lift Plan carried out?
- Were shortcuts taken because of time pressures?
- Is the load adequately secured and balanced with multiple rigging points?
- Is an exclusion zone in place so that if there is a failure we can fail safely?
- If lifting with an excavator, is it set up to lift?
