Alert

Outline the Scene	Incident	Laceration below right knee
	Subject	Falls on the same level
	Incident Date	06-03-2024
	Business Unit	Fletcher Living – North

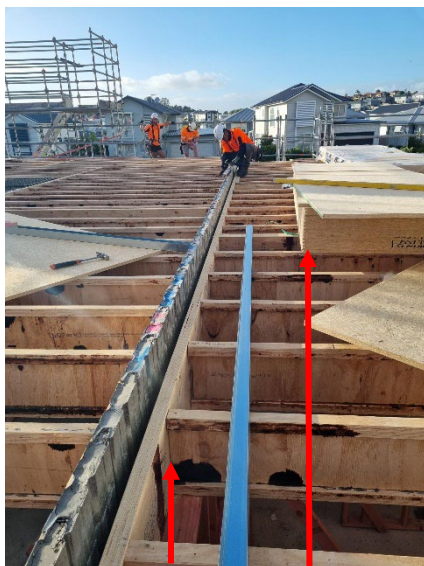
Joists & Strandfloor

IP was in the process of installing Strandfloor and whilst walking on the mid-floor joists, he caught his boot on a corner of a sheet of Strandfloor and tripped landing only a short distance away on top of the Korok intertenancy wall.

- Is material placed as to not create slip/ trip hazards?
- Have you considered capping the Korok before the installation of strandfloor?
