<b>Outline the Scene</b>	<b>Incident</b>	<b>Laceration to leg from nail plate</b>

<b>Critical Risk Type</b>	NCR01 – Contact with hot or sharp objects
	<b>Incident Date</b>	23-07-2024
	<b>Radar Reference</b>	INCID-0080851
	<b>Business Unit</b>	Fletcher Living North – Western Heights

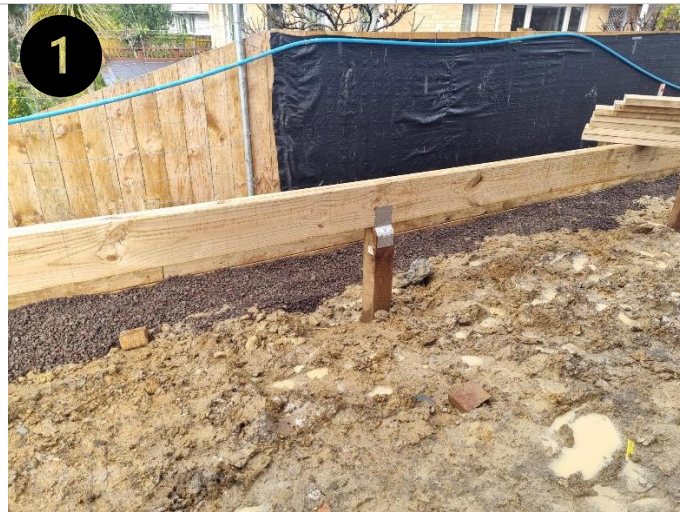
IP returned, after getting more nails, to complete nailing off the nail plate to the deck bearer when he slipped on slightly sloping muddy ground and cut his inner right calf on the edge of the protruding nail plate that hadn't been nailed off completely. The bottom half of the nail plate was positioned at a 45 degree angle, protruding into the open air ready to be bent down and nailed off on the front face of the pile.

**Image 1: Ground conditions with now nailed off plate**

- Have we considered the ground conditions prior to contractors starting work?
- Have we considered weather implications to ground conditions?
- Has the contractor done a pre-start?
- Have we installed the nail plate as per the manufacturer's guidance?

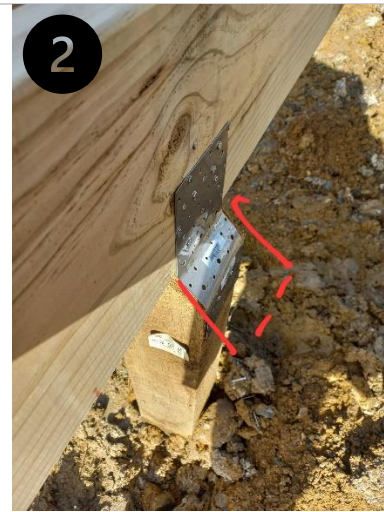
**Image 2: Nail plate with position (in red) at the time of the incident**
