## Customer Care Learn Document

### Managing Control Joints in Block Wall

Outline the Scene	Issue	Managing control joints in block wall

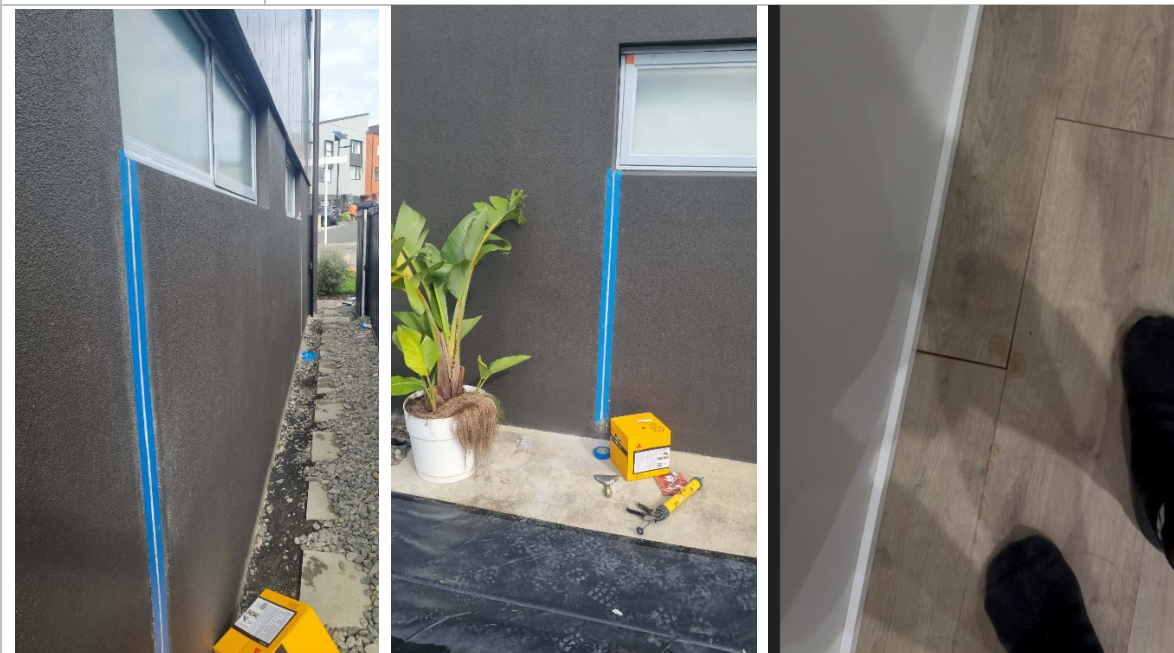
- Ground floor block control joints failed from a weathertightness (E2) perspective, allowing water ingress. Structurally compliant, but E2 detailing not effectively delivered in design, procurement and construction.
- Issue replicated across 4 buildings → amplified impact and complexity (multi-owner, multi-stakeholder). Required Building Consent to validate remediation and provide assurance to more than one Body Corporates.
- External remediation (sealant + replaster) under the consented work + Internal remediation of multiple units that had internal moisture damage (flooring, lining and trims)
- Cost impact to business (\$100K+ in total)
  - \$50K+ external works (consented scope)
  - Additional internal remediation (4 units)
  - Customer costs (accommodation + compensation)
- Time impact (internal resources)
- Reputational impact (leak)
