| Outline the Scene | Incident | 11Kva Cable strike |
| | Subject | Cable strike |
| | Incident Date | 23/07/2021 |
| | Business Unit | Fletcher Living – Canterbury |

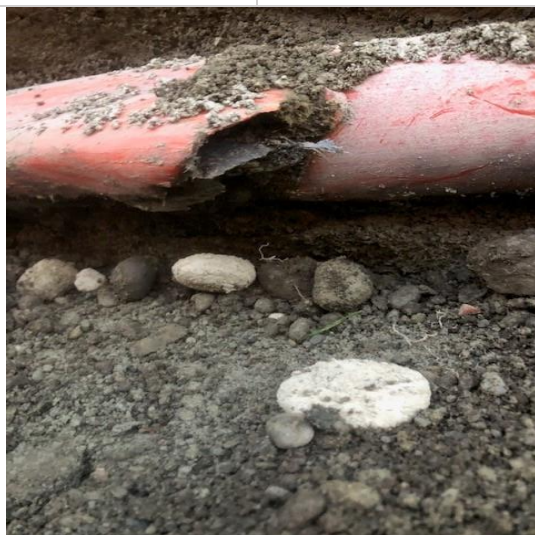
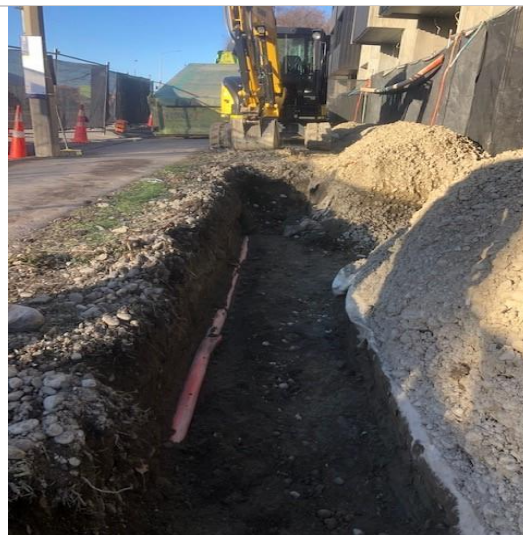
On 23<sup>rd</sup> July 2021, whilst trenching for foundations using a 5 TON excavator, a Contractor struck an 11kva cable buried approx. 600mm below ground level.

The Orion Faults team arrived onsite approx. 1hr later notifying FRL management that they had a fault in their line. On investigation the damaged cable was found approximately 4m away from where the contractor was working. There was no evidence of danger tape in the proximity where the cable was exposed.

No injuries or other damage occurred as a result

1. Have clear precise communications been had prior to any marking out and breaking ground?
2. Has the correct location for ground penetration radar been confirmed and marked out prior to commencement?
  - a. Have the right people marked out the location?
  - b. Have they been marked on the ground?
3. Have the As-built drawings been checked?  
<https://www.beforeudig.co.nz/nz/home>
4. Is hydro-vac being used or considered to confirm location of presumed services?
5. Are Contractors following their own procedures?  
JSA/TA/SWMS/Permit
6. How accurate is the ground penetration radar?
7. Is the contractor aware of the FRL incident notification requirements?
