# Learn

| Outline the Scene | Incident | Digger Overturned |
| | <b>Subject</b> | Mobile Plant |
| | <b>Incident Date</b> | 29-03-2022 |

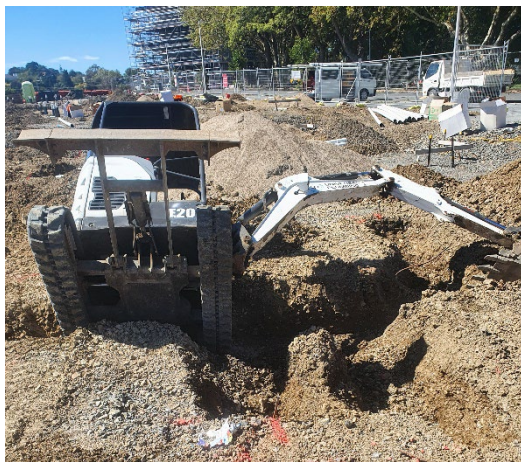
The operator was working on the under-slab drainage. He was in his compact excavator and digging a side trench to join up with the main trench. He was positioned next to an existing smaller trench on his left and the open main trench directly behind him. The operator noted that his left track was partially hanging over the trench on his left. He swung the arm to the left and placed it on the opposite side of the smaller trench, with the intend of taking the weight off the left track. Moving the arm shifted the centre of gravity, and since the excavator was very close to the main trench (possibly even overhanging a bit), this shift caused the corner of the trench to cave in and the excavator to slid backwards into the trench. The operator fell out of the digger and onto the ground adjacent to the trench. He did not sustain any serious injuries.

- Did the pre-start meeting include discussions around ground conditions?
- Are the safety features being used as intended (i.e. seatbelt worn)?
- Have we considered if there are any mental distractions preventing us from focussing 100% on the task at hand?
- Is the TA/SOP detailed enough to include all hazards, including competency requirements?
