# LEARN

| <b>INCIDENT</b> | Fall from Height |
| <b>BUSINESS UNIT</b> | Fletcher Residential |

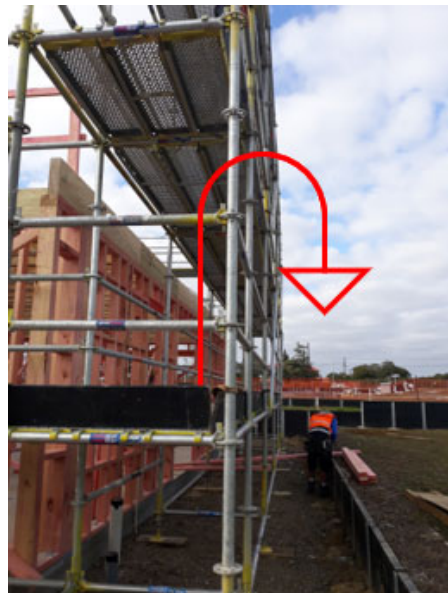
At approximately 2:15pm on the 8<sup>th</sup> of September, a contractor was leaning out the scaffold from the first lift talking to his co-worker who was one level up. He leaned out too far and lost his balance and fell over the handrail. He could grab hold of the bracing during his fall and this slowed his fall as well as allowed his feet to swing around towards the ground. However, he couldn't hold on and fell the rest of the way to the ground. He landed on his front with his arms taking the brunt of the impact. He also hit his cheek and chin when he landed. No serious injury was sustained.

- Scaffold confirms to the Good practice Guidelines for Scaffolding on WorkSafe's website – Handrails must be installed at 900mm – 1100mm with a midrail installed between the working platform and the top handrail. Handrail was installed at 1000mm
- Contractor has been working two jobs and has not been getting enough rest.
- Is there anything else we can do to make our scaffold safer?

| Element | Corrective Action |
|---|---|
| Working Safely at Heights | Trialling additional handrail at 1500mm |
| Worker Engagement | Toolbox Talk on Fatigue (To be drafted) |
