# LEARN

| <b>INCIDENT</b> | <b>A0/P4 Live underground cable strike</b> |
| <b>SUBJECT</b> | Underground Services |
| <b>BUSINESS UNIT</b> | FRL – Auckland South |

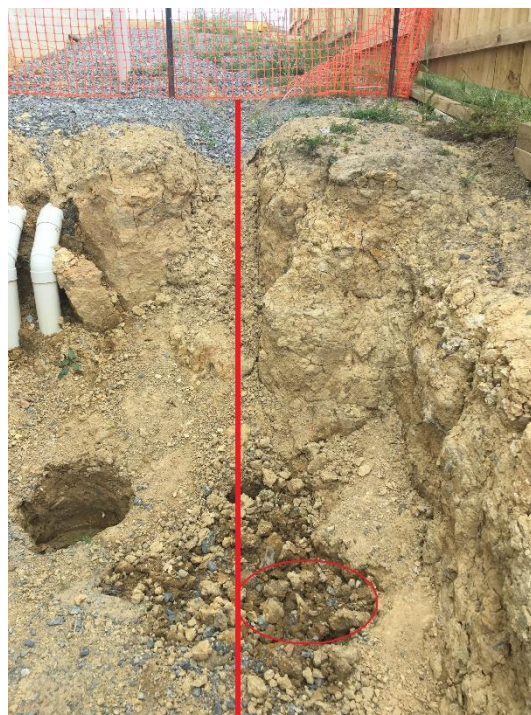
A fencing contractor was coring a series of post holes adjacent to a live service trench with an auger attached to an excavator. Upon commencing the drilling of the third hole (ringed on the photo), the excavator operator noted little resistance to the auger and stopped, lifting the auger from the hole. The spotter noticed there was something in the ground. Thinking it was an offcut of reinforcement, he started clearing the clay around it by hand. It was at this point he noted it was in fact an electrical cable, the line of which is noted on the photograph. The cable had been damaged by the auger. There was no warning tape or fines and the depth was approximately 350mm.

Work was stopped, an exclusion zone was placed round the hole and the supervisor was contacted

- FRL Working Near Underground Services Guidelines were not followed
- Contractor Task Analysis were not followed nor fit for purpose

| Element | Corrective Action |
|---|---|
| <b>Supervision</b> | FRL Supervisors to use guidelines and issue permits to dig.<br>FRL Construction Managers to review and sign-off contractor task analysis. |
| <b>Contractors</b> | Meeting held with relevant contractors to explain expectations regarding guidelines.<br>Contractors to co-ordinate with supervisors each time they intend breaking ground on site. Accurate as-built drawings to be kept on site and shared with FRL Supervisors.<br>Contractor task analysis to be updated in line with underground services guidelines. |
