# Alert

| Outline the Scene | Incident | Outrigger sunk |
| | <b>Subject</b> | Crane Operations |
| | <b>Business Unit</b> | Fletcher Living – Auckland North |

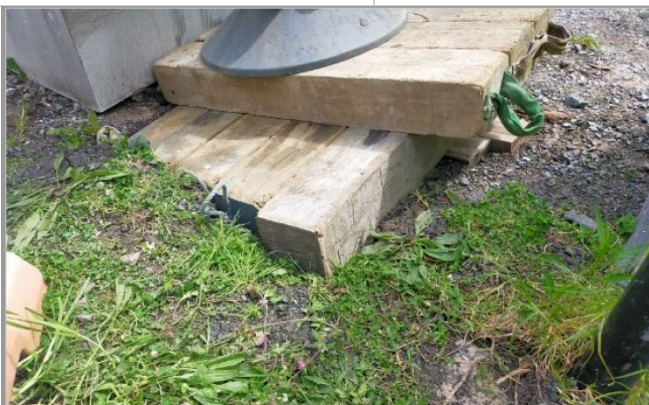
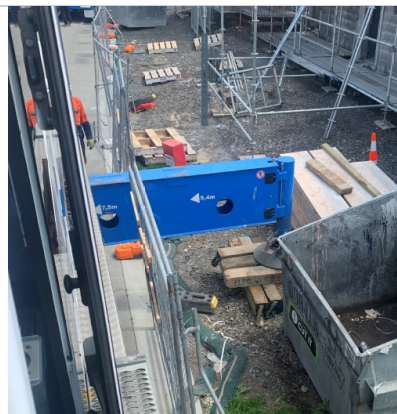
While placing an 8-ton balcony the operator noticed a drop in pressure on one of the outriggers. The crane had been placed halfway across the laneway and the lot.

After noticing a drop in pressure, the operator put the balcony back onto the truck to reset the leg. Whilst resetting the outriggers with more support the outrigger leg sunk after trying to relevel the crane.

After investigation, while at initial visual check the ground conditions appeared satisfactory, one of the outriggers was placed directly over the service trenches, causing the unstable ground conditions.

- Competence is very important
- Always check ground conditions prior to deliveries – with particular attention to service trenches.
- All complex lifts should be supervised
- Lift plan should be drawn up, reviewed and signed off prior to any lift started.
