| | <b>Outline the Scene</b> | <b>Incident</b> | <b>Steel worker climbing through scaffold rails</b> |
| | | <b>Subject</b> | A0/P4 Fall from Heights |
| | | <b>Business Unit</b> | Fletcher Living - Central Branch |

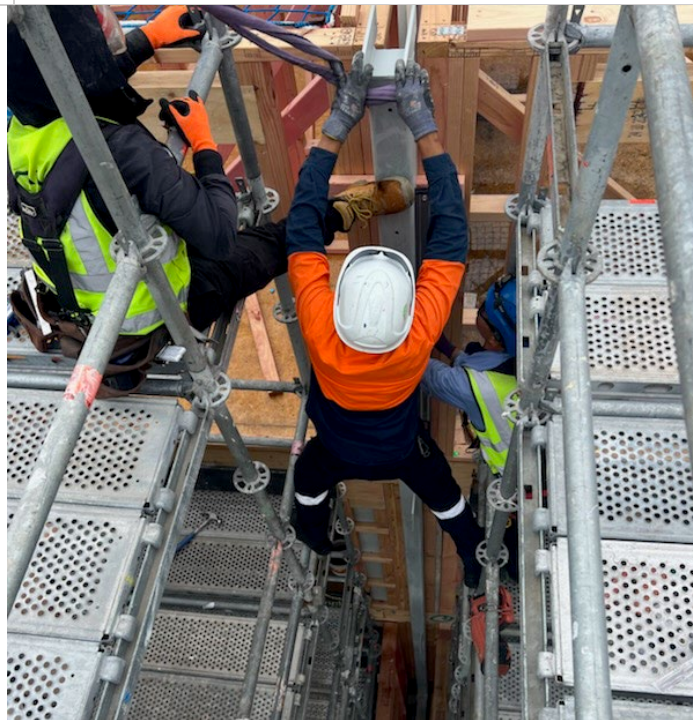
The steel fabricators used a Hiab to lift and secure the post in place. One worker was seen climbing over the safety rails on the third level of the scaffold, positioning himself between the scaffolds to detach the lifting strop from the post. This placed him directly above a three-level void. Another contractor noticed this and instructed the steelworker to return to the safety of the scaffold. The worker did not comply right away, finishing the task of releasing the strop first, and the project manager was subsequently informed.

- The carpentry team, steel installer and Hiab operator were not able to directly communicate with one another due to language barriers. During pre-start meetings, we need to ensure we use translators or apps to translate to ensure everyone understands what is required of them. Pre-start meetings also to be documented moving forward.
- When tasks are not progressing as planned, contractors to pause and re-assess before continuing

- Crane operator to ensure he positions himself to have full visibility of the operation or alternatively use a qualified dogman.
- We've commended the contractor who reported the incident to management to encourage others to speak up when they see something that is unsafe.
