Outline the Scene	Incident	Partial trench collapse

Subject	Section of clay dislodged
	Incident Date	07/04/2025
	Business Unit	Fletcher Living - Central Branch

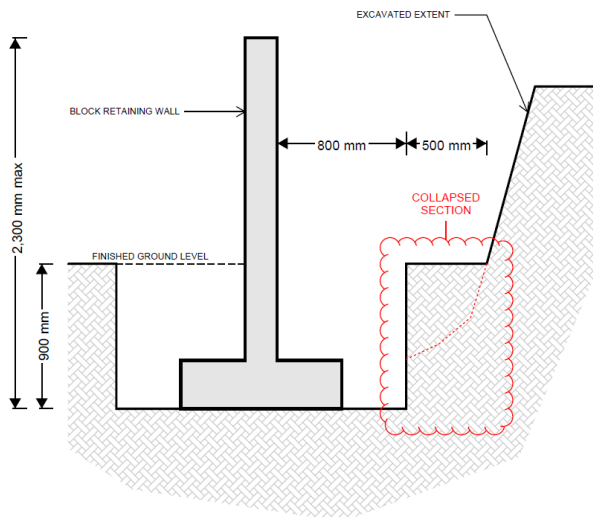
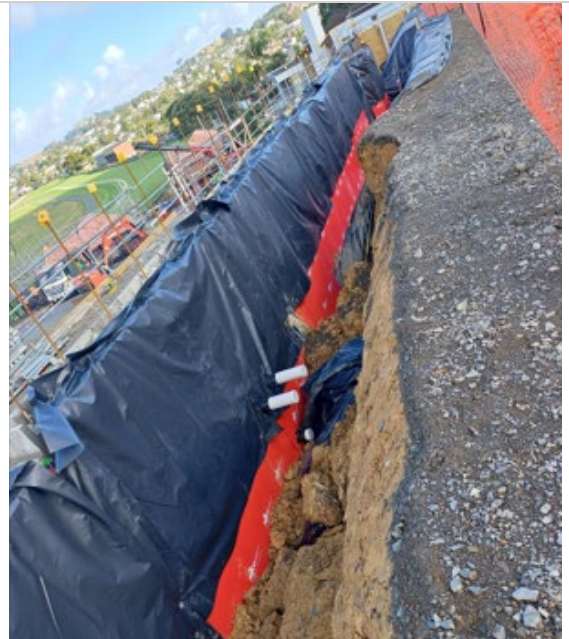
On site we have a ground level difference of 1.7m at the highest point stepping down at each lot. The retaining design is a poured block wall and concrete foundation that is 900mm below ground level. The agreed methodology was to excavate a 1m bench then battered to an angle of approx. 45° and cover with PVC to protect from weather that may contribute to collapse of the soils. Due to space constraints, a section was only benched for 0.5m and not battered to the same extent. During construction there was a heavy downpour of rain on Friday and workers were informed not to access the trench area. Upon returning to site on Monday, we observed that a section of the benching had detached and slipped into the trench.
