| | <b>Outline the Scene</b> | <b>Incident</b> | <b>Roof Skylight, Potential Fall</b> |
| | | <b>Subject</b> | Uncovered Penetration |
| | | <b>Incident Date</b> | 16-07-2021 |
| | | <b>Business Unit</b> | Residential – Auckland North |

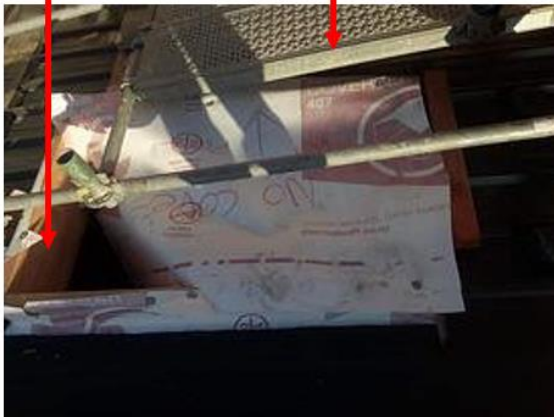
A scaffolding contractor was stripping scaffold from a roof on a terrace block of residential housing. The scaffold was a lower roof platform that straddled two open skylights. The Skylight opening was covered only by building paper and marked with pen but did not clearly warn people to the risk of a fall. The scaffolder stepped onto the building paper expecting there to be support beneath. His foot went through the building paper, however he managed to prevent his fall by grabbing the scaffold which prevented him falling through the skylight. The fall would have been 3.5 metres.

Stepped through building paper

Lower roof Scaffold platform

Lower Roof

Cover (Plywood) skylight hole

- Do you have a process in place to identify and cover open penetrations?
- Ensure all/ any open penetrations are adequately covered
- Ensure coverings are robust and cannot be removed and can withstand human weight
