Outline the Scene	Incident	Service Strike During Signage Installation

Subject	Underground Service Strike
	Critical Risk Type	CR10 – Contact with Underground Services
	Radar Reference	INCID-0075477
	Business Unit	Fletcher Residential – South Branch

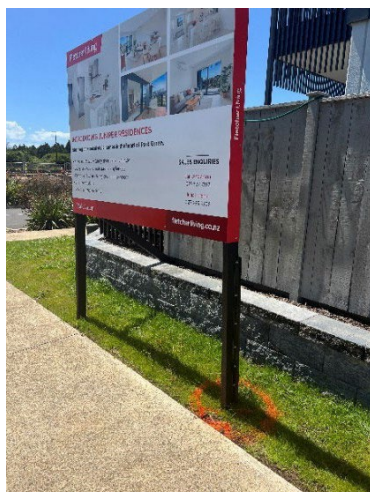
SM noticed power was out to half the Park Green Unit Over Unit block and logged a fault with Counties Power. Counties Power notified us that the mains cable had been struck with a metal waratah, which was live (100v) and had been for a couple of days. The waratah had been bolted to the side of the timber post to provide additional support and strength to the large sign. Counties Power disconnected power to the affected circuit and referred internally to another team to carry out permanent repairs. Permanent repairs were completed, and power restored. FRL signage installers were contacted and a review of their paperwork and processes is being undertaken to ensure they are appropriately managing the risk going forward.

- Have we completed a Permit to Excavate before undertaking any work that involves ground penetration (including waratah installation)?
- Have we consulted all the correct plans to consider what services might be where underground?
- If there are services present, could we install the sign on a fence or in an alternative location to avoid working near them?
- Have our signage installers been through and EHS induction and provided all of the relevant paperwork prior to beginning work?
