| Outline the Scene | Incident | Service Strike During Signage Installation |
| | <b>Subject</b> | Underground Service Strike |
| | <b>Critical Risk Type</b> | CR10 – Contact with Underground Services |
| | <b>Business Unit</b> | Fletcher Residential – South Branch |

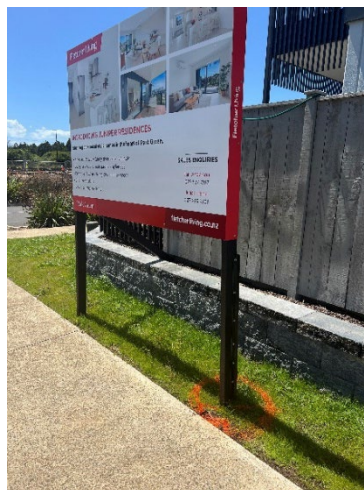
SM noticed power was out to half the Park Green Unit Over Unit block and logged a fault with Counties Power. Counties Power notified us that the mains cable had been struck with a metal waratah, which was live (100v) and had been for a couple of days. The waratah had been bolted to the side of the timber post to provide additional support and strength to the large sign. Counties Power disconnected power to the affected circuit and referred internally to another team to carry out permanent repairs. Permanent repairs were completed, and power restored. FRL signage installers were contacted and a review of their paperwork and processes is being undertaken to ensure they are appropriately managing the risk going forward.

- Have we complete a Permit to Excavate before undertaking any work that involves ground penetration (including waratah installation)?
- Have we consulted all of the correct plans to consider what services might be where underground?
- If there are services present, could we install the sign on a fence or in an alternative location to avoid working near them?
- Have our signage installers been through and EHS induction and provided all of the relevant paperwork prior to beginning work?
