| <b>Outline the Scene</b> | <b>Incident</b> | <b>Steel Installer accessing beam with no fall protection</b> |
| | <b>Subject</b> | Falling from height |
| | <b>Incident Date</b> | 10-09-2025 |
| | <b>Business Unit</b> | Fletcher Living – Auckland Central North |

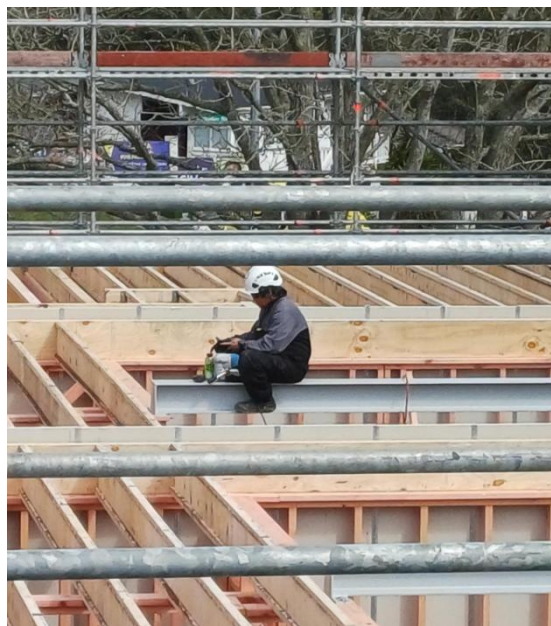
A steel installer was drilling holes in a structural steel beam as part of remedial works. The Beam had been installed and bolted to the top plate however the midfloor joists were unable to be installed as the beam was not pre-drilled to receive packing timber.

The steel installer was using a ladder to access the beam, to gain additional height they climbed on top of the beam and continued to drill holes while straddling the beam.

The Worker was seen by a FRL employee who notified a site manager. The Site manager stopped the worker from completing the job and told them to come back down to the ground.

- Steel worker did not report to the site manager when arriving onsite
- Worker was not inducted to site and took instruction from the carpentry team
- Ladder used was not appropriate for task

- Induction of worker including agreeing to follow the company's own Task analysis
- Site protocols explained to worker and PCBU, a mobile scaffold was onsite and should have been used for the task.
- PCBU to conduct prestart meetings prior commencing works
