| | <b>Outline the Scene</b> | <b>Incident</b> | Uncovered Penetration Leads to Falling Core |
| | | <b>Subject</b> | CR06 - Objects falling from height |
| | | <b>Incident Date</b> | 5/11/2025 |
| | | <b>Business Unit</b> | Fletcher Living – Canterbury |

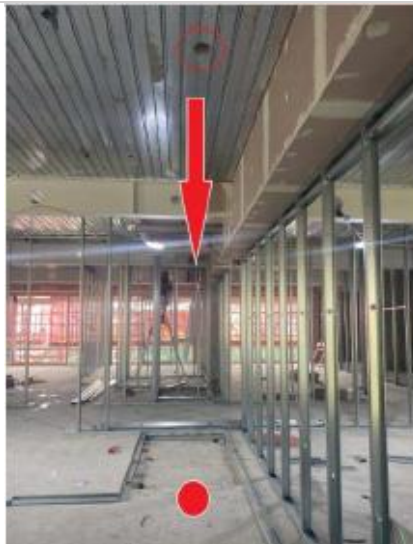
During core hole drilling on Level 3, a 5kg concrete core became dislodged and fell into the designated exclusion zone on Level 2. What wasn't expected was that the core continued its path through a corresponding penetration that was partially covered with loose insulation batts, which were displaced, before finally landing on Level 1 – where no exclusion zone was in place.

- Were lower-level penetrations controlled using fixed, hard covers as an engineered barrier before drilling?
- Do we apply the CCV: Objects Falling from Heights to core drilling?
- Was a pre-task risk assessment completed for potential falling objects through multiple levels?
- Was the risk of falling objects through multiple levels for this task recognised, or underestimated?
