| <b>INCIDENT</b> | <b>A0/P3 Window fell from height</b> |
| <b>INCIDENT DATE</b> | 21 <sup>st</sup> September 2020 |
| <b>BUSINESS UNIT</b> | FRL – Auckland South |

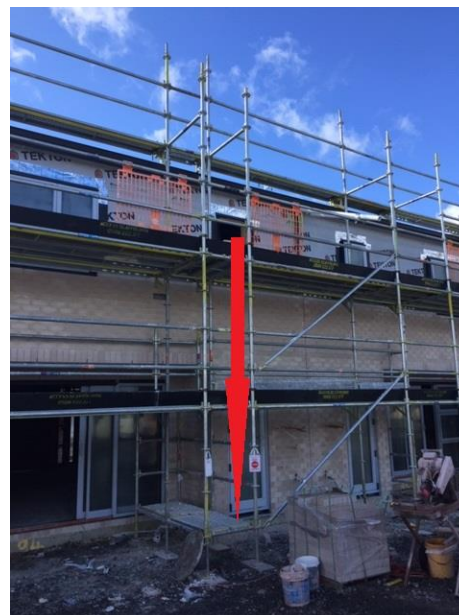
A bricklayer, working on the upper lift of the scaffold, had been kneeling and went to stand. He grabbed the side of the window frame and pulled himself up. Upon letting go of the frame, it came loose from its position, falling between the scaffold and the brickwork, landing on the ground below.

The bricklayer notified the Supervisor immediately. Upon investigation, it appears the window has not been secured correctly into the jamb as part of the manufacturing process. The Supervisor contacted the supplier who was in the vicinity. The supplier checked the rest of the windows for any similar issues.

- The aluminium window had not been fixed into the timber jamb with staples during the assembly process as per the standard detail. The cause of this was human error.
- No recorded quality control process existed in the assembly plant. An error like this would have been identified and corrected had such process been in place.

| Element | Corrective Action |
|---|---|
| <b>Contractor</b> | Recorded quality control process created and launched in assembly plant.<br>Quality Control sticker placed on glazing to notify site team window has been passed. |
| <b>FRL</b> | Supplier quality control processes to be considered during onboarding process.<br>FRL proposed new fixing detail which is to be trialled in March. |
