# Alert

| Outline the Scene | Incident | Failure of safety net |
| | <b>Subject</b> | Fall from height |
| | <b>Business Unit</b> | Fletcher Living – Central Branch |

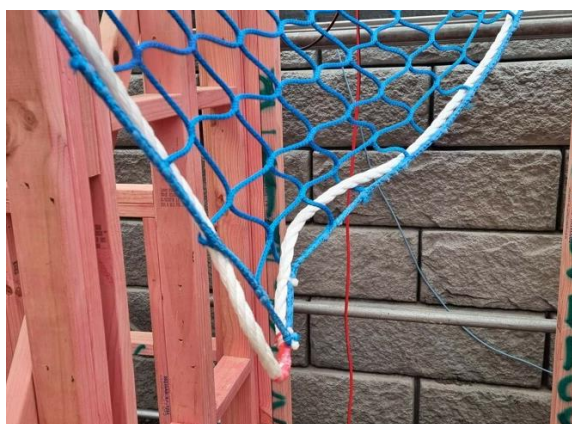
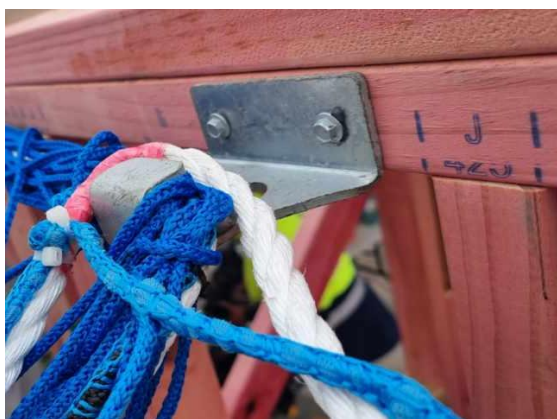
A contractor stood on the safety net to get on top of the next wall. The safety net came undone, and the worker fell through the gap and onto the floor below. No serious injuries were sustained. Initial assessment indicates that the bracket was overfilled, and the nets were not tied together where they overlap.

- 1) Are the controls installed correctly?
- 2) Are the controls used as intended and contractors aware of the limitations on the controls?
- 3) Have we considered if there are safer methods to complete the work?
