| | <b>Outline the Scene</b> | <b>Incident</b> | <b>Brick Saw – Cut to left index finger</b> |
| | | <b>Subject</b> | Power Tools |
| | | <b>Business Unit</b> | Fletcher Living – North |

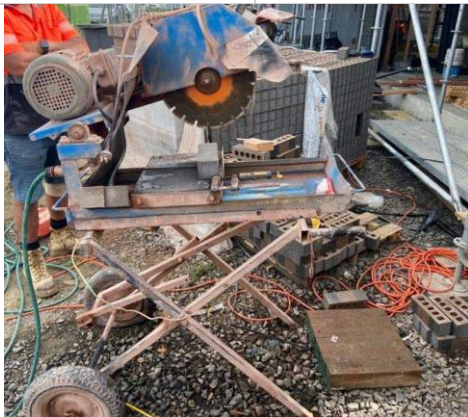
Whilst placing a brick on the brick saw guide, an operator has moved her hand too close to the saw blade and her left index finger had made contact with the blade. The result of this was a minor cut requiring butterfly stitches. The operator was loading and discarding off cuts in a “criss – cross fashion”. The brick saw was not set up level which caused the brick guide to slide to the middle causing the operators hand to be closer to the blade when operating. The operator has not received training in a language she understands and competency was not confirmed.

In an ideal situation bricks should be fed from the left hand side and off cuts discarded on the right hand side. This was done in the opposite direction on the day (“criss cross”)

- Has the set up been planned in advance to allow enough operating space?
- Will the process of set up flow i.e. left in, dispose right?
- Has an exclusion zone been established?
- Is the operator competent and how is competency confirmed?
- Has the saw been set up level?

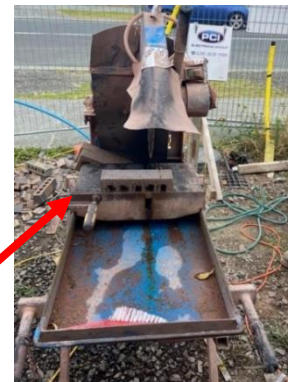
**Arrow also points to brick guide.**
