| Outline the Scene | Incident | Electric Shock from Damaged Power Cable |
| | Subject | Fencing contractor damaged a power cable and received an electric shock when removing spoil with hands |
| | Critical Risk Type | CR07-Contact with Electricity |

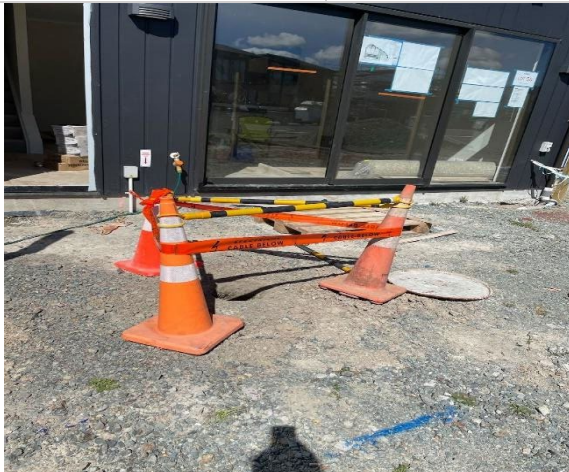
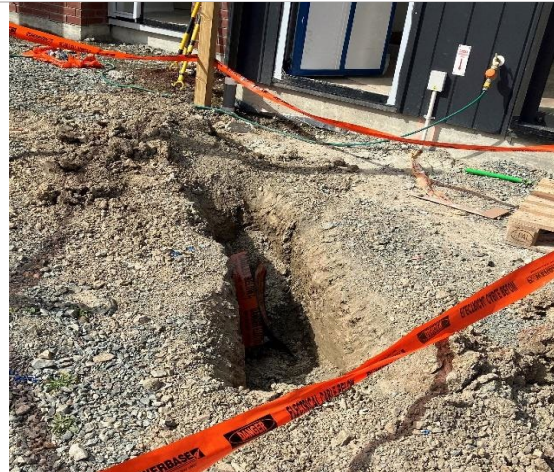
Whilst in the process of drilling post holes with a mechanical auger, a fencing contractor has stopped work after he hit something in the ground. To determine what he hit, the contractor used his hands to move the spoil and in doing so touched an exposed 230v electrical cable. He was promptly transported to a medical centre for assessment, where an electrocardiogram (ECG) was performed. Following the evaluation, it was determined that he was cleared to return to work. To address the hazard, the services of Vector were sought to disconnect the power. The hole was covered, and an exclusion zone was set up.

- It is essential to ensure that protocols are regularly reviewed and effectively communicated to both employees and contractors.
- Before commencing any excavation work, it is necessary to obtain an As-Built plan that shows the location of services.
- Prior to any excavation work, it is necessary to obtain a permit to dig.

- Contractors' Task Analysis must take into account the on-site activities and require workers to be strictly adhere to the stated controls and signed on to them.
- The laying of services must be done at the correct depth, and the details should be recorded in the As-Built plan.
