Incident	Flash Spark
	Subject	Flammable Burn
	Incident Date	09/08/2021
	Business Unit	Fletcher Living – Canterbury

What happened

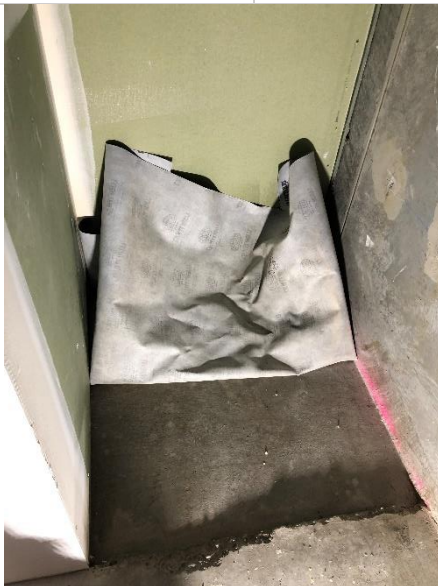
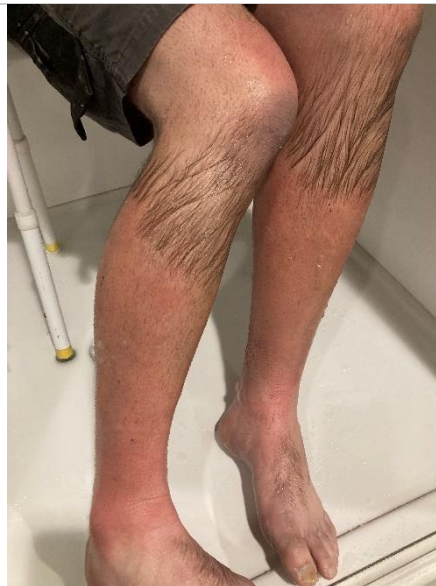
On 09th August 2021, whilst laying waterproofing membrane within a bathroom/shower room. A contractor received minor burns to his lower legs.

The contractor was using Maxilam Sabre Grip S41 product which is applied via a canister spray to the underside of the waterproofing. Following the application, the contractor smoothed down the membrane. Upon doing this the contractor noticed a flash spark which caused a flame along the ground coming from the left out in the hallway.

- The shower room had no external ventilation due to it being an enclosed room.
- The temperature that day was 2-5 degrees
- No extraction fan was been used
- Power tools were in the shower room and proximity
- Painters were also working in a room next door to the shower room in the same unit spray painting with areas sealed off and electrical cables present.

1. Have clear and precise communications between contractors been had prior to any works taken place?
2. Is the Safe System of work applied as per the SDS and Task Analysis?
3. Are the workers wearing suitable PPE for the task?
4. Should other contractors be using chemicals and electricity working in the same area at the time of using flammable products?
5. Has the contractor selected the right tools for the task?
6. Are there safer/alternative products available for the task, Safe to use?
