| Outline the Scene | Incident | Framing Nailer vs Finger |
| | <b>Subject</b> | Working with Powertools |
| | <b>Critical Risk Type</b> | NCR01 - Contact with hot or sharp objects |

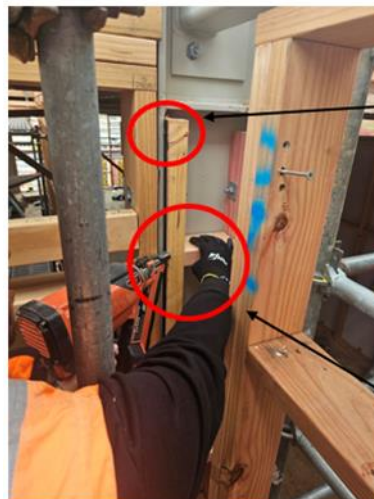
A carpenter was installing a nog for a wall fixing, to fix off the nog they used a framing nailer using 90mm nails. Access to the wall was restricted due to the scaffold system in place. During the installation the carpenter has been holding the nog in close proximity from the nailer. Using their non dominant hand they have then shot into a knot within the timber, this has caused the nail to deviate and penetrate their finger.

IP drove the nail into the knot

Note - Right hand positioned in the line of fire.  
(Not the position during the incident but similar)

- Is the workspace sufficient for the task?
- Are workers avoiding shooting nailer directly through knotted part of timber?
- Could an alternative tool or fixing be used for the task? i.e. drill & screw
- When using nail gun, are hands and other body parts a minimum of **300mm** away from the tip of nailer?
