| Outline the Scene | Incident | Outrigger extended when driving |
| | <b>Subject</b> | Outrigger |
| | <b>Business Unit</b> | Fletcher Living – Canterbury |

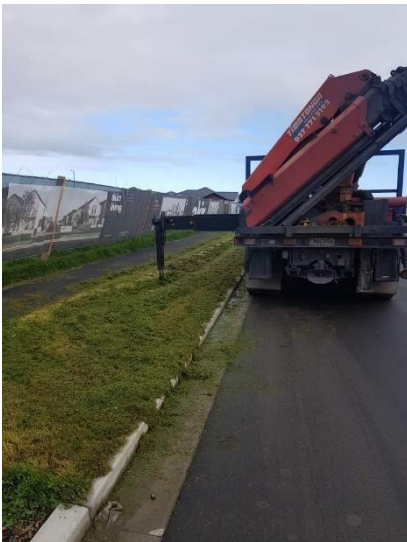
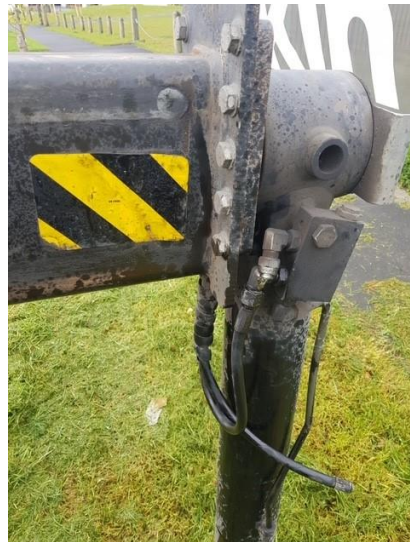
On 14<sup>th</sup> October 2021, Delivery driver packed up his truck and proceeded to leave site, upon leaving the outrigger on the passenger side rear was still extended.

The workers onsite managed to get the drivers attention before he left site, the outrigger clipped a temporary fence panel in the process with little damage.

On investigation the hydraulic hose was damaged and possible cause for the outrigger to have not returned correctly, the warning alarm was also faulty. Prestart checks had been carried out; however, the audible alarm is not included in the prestart checklist.

1. Have pre-starts checks been carried out prior to the trucks leaving the yard for the day.
2. Are any faults actioned straight away?
3. What checks are carried out when the delivery has finished and leaving the site?
  - A. Ensuring the outriggers are retracted correctly and secured
  - B. Ensuring the Crane is retracted correctly
  - C. All Cones and items are secured
4. Are Contractors following their own procedures?
