# LEARN

| <b>INCIDENT</b> | <b>INCID – 0045152</b> |
| <b>SUBJECT</b> | Roofing Material fell from Height |
| <b>BUSINESS UNIT</b> | Fletcher Residential – Auckland Central |

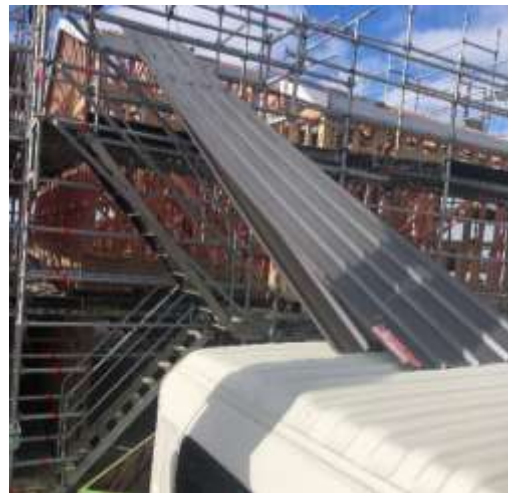
At 11:30 AM on Wednesday 5<sup>th</sup> May at the Derna Tobruk development a roofing contractor was unloading roof sheets onto the roof from the delivery vehicle using a Hiab crane. The roofer had used three 55mm Tek screws to skew fix a section of timber to the purlins to prevent the material from sliding off the roof. They had placed the first load into position and were working on releasing the straps from the second load when the first load came undone. The sheets slid through the scaffold guardrails and landed on the cab of the truck parked below. There were no injuries and minor damage to the roof of the truck's cab.

- The screws used to secure the timber acting as stopper were shorter (55mm) than the 75mm screws usually used.
- The roofer was inexperienced in installing stoppers. This was his first time undertaking the task without supervision.
- Site procedures were not followed. Roofer and delivery driver were not inducted to site, they did not follow our exclusion zone requirements.
- Procedures around incident reporting were not followed correctly.

| Element | Corrective Action |
|---|---|
| <b>Contractor Management</b> | Roofing contractor to amend their stopper installation method and record this in their Task Analysis and Method Statement. All employees to sign it.<br>Contractor to communicate FRL requirements to their sub-contractors and provide proof that they have done this. |

| <b>EHS Assurance</b> | Spot checks to be done by EHS team/Site Supervisors over the next six months to ensure roofing contractors are using the agreed method of stopper installation. |
| <b>Supervision</b> | Contractors to ensure inexperienced workers are suitably supervised.<br>FRL supervisors to provide onsite guidance on compliance with FRL requirements. |
| <b>Planning and Implementation</b> | If longrun is to be used on roofs pitched over 20° then an alternative method of loading to be considered e.g. onto the scaffold platform then passed on manually |
