| <b>Outline the Scene</b> | <b>Incident</b> | <b>A3 Serious Injury –Severed hand tendon</b> |
| | <b>Subject</b> | Marking out and installing purlins |
| | <b>Incident Date</b> | 19-09-2022 |
| | <b>Business Unit</b> | Fletcher Living – North Branch |

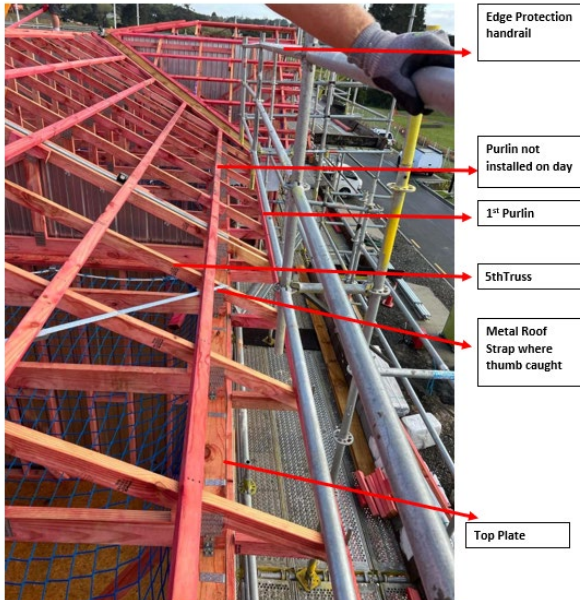
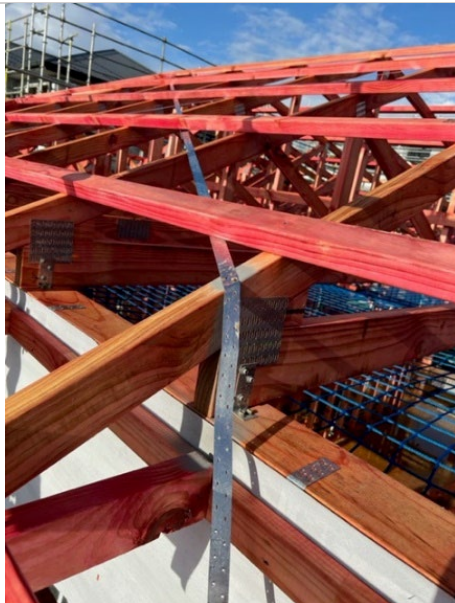
| <b>What happened</b> | <p>Whilst in the process of preparing to mark out and install purlins the IP was queried by his team about the purlins. He walked on the top plate toward them while holding on to the handrail of the roof edge protection. On his way to the team, whilst walking on the top plate, a co-worker was in the IP's way. As the IP stepped around his co-worker, he placed his foot onto the 4th truss to get around him. It was at this point that his foot slipped, and he lost grip of the handrail. Whilst falling he used his left hand to stop his fall by grasping onto the top chord of the 5<sup>th</sup> truss. His hand slid down the top chord into the metal roof strap cutting a V-shape into this left thumb severing the tendon. IP followed the correct procedure for marking out and installing purlins.</p> | |
| | <ul style="list-style-type: none"><li>• It was raining on the day, however not when the incident occurred. This led to the trusses being wet and subsequently slippery.</li><li>• The roof was sloped at 25 degrees and damp creating a slip hazard if utilised.</li><li>• Whilst adequate and compliant roof edge protection was in place the design was not practical. This created a congested working area which led to the IP having to step around his co-worker onto the truss to get around him.</li></ul> | |

- Scaffold set up when using our new product, metal fascia can be improved to provide better access for both fascia / gutter install and roof access for purlins. This is being implemented.
- When reviewing task of installing purlins in general we believe that it will be a lower risk task if we move to installing purlins at 450mm centres (vs usual practise of 900mm). This will be implemented moving forwards.
- Sharing this incident with all contractors reiterating importance of gloves policy.
