Alert

Outline the Scene	Incident	Cut to left wrist with angle grinder
	Subject	Cutting Rondo
	Incident Date	3-11-2023
	Business Unit	Fletcher Living – South Branch

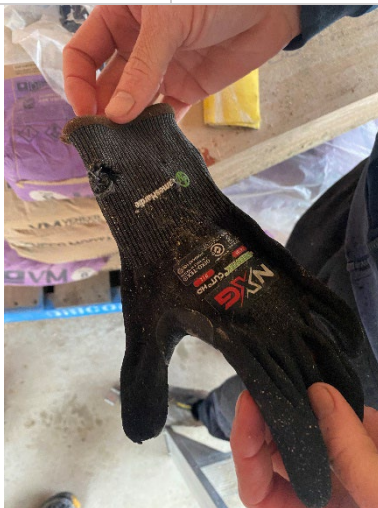
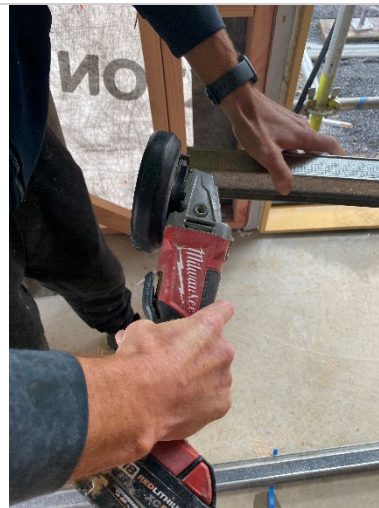
What happened?	Worker was cutting 3 rondo ceiling battens with a battery angle grinder which had a guard on. One end of the rondo was up on a nog whilst the worker held the other end with left hand and grinder in right, his hand was positioned too close to the cutting area and when he had cut most of the way through, the rondo offcut dropped causing the grinder to jam and lurch up into his left wrist causing a small laceration. Worker went to Waiata Medical Centre where he received two stitches.
-----------------------	---

We believe all injuries are preventable, here are some questions to help us learn	
	<ol style="list-style-type: none">1) Was the angle grinder the right tool for the task?2) What other methodologies could be considered to complete this task? Including a suitable work platform?3) Do we need to provide additional resources on correct body positioning and cutting techniques?
