<b>Outline the Scene</b>

<b>Incident</b>	Electrician dislocates pinkie finger at top knuckle
	<b>Subject</b>	Finger caught in rotating tool
	<b>Incident Date</b>	22-05-2025
	<b>Radar Reference</b>	INCID-0089582
	<b>Business Unit</b>	Fletcher Living – Canterbury

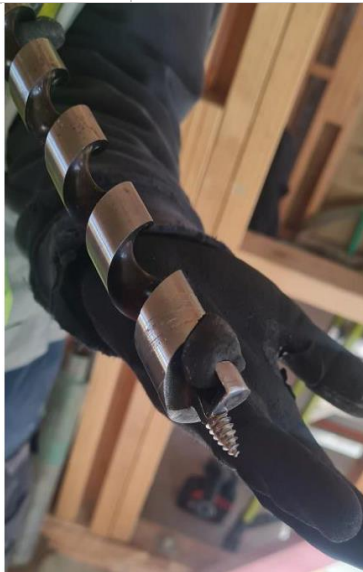
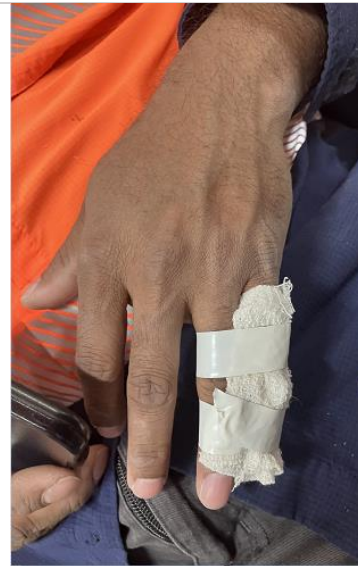
While drilling cable holes through nogs from a 6-step platform ladder with a full safety rail, an Electrician has dislocated his left pinkie finger. He was using a driver drill with a side handle and a 450mm auger bit and wearing full PPE, including cut-resistant gloves. While facing an exterior wall near a ranch slider cavity, the drill bit travelled on an angle to avoid a metal strip has become stuck and the chuck has loosened. The worker has removed one hand from the handle and, while tightening the chuck with his free hand, has pressed the trigger. His pinkie was caught in the rotating parts, resulting in a dislocation at the top knuckle.

- When working with power tools that can cause entrapment, can we isolate the energy source before placing our hands near the rotating parts?
- How often are our contractors holding internal training and toolbox talks around hand safety?
- Should the supervisors of our contractors have more involvement during task analysis sign on at inductions?
