Outline the Scene

Incident	Site hoarding blown over in inclement weather.
	Subject	Temporary Works
	Incident Date	12-10-2021
	Business Unit	Fletcher Living - Canterbury

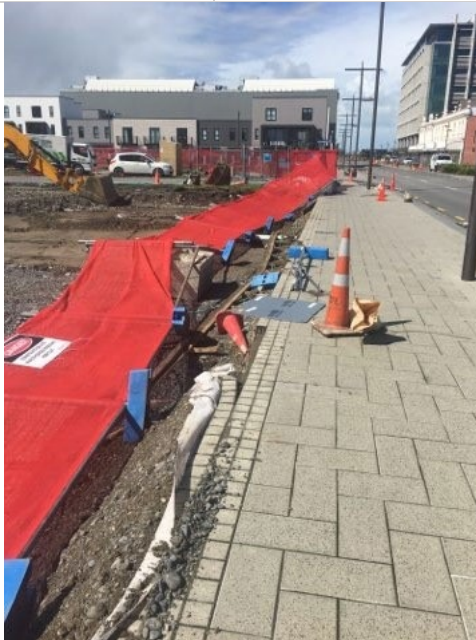
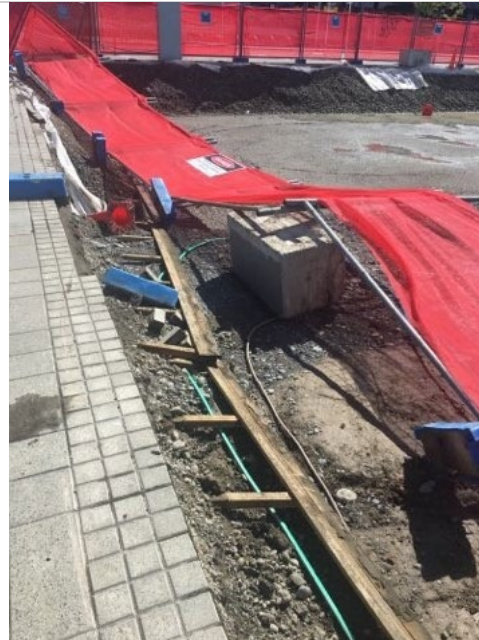
Contractors were undertaking site remediation works. The weather at time was wet with strong and gusting winds. A perimeter fence (consisting of fence panels covered with scrim, with M10 anchors through 2 x fencing clamps, secured to the base of concrete bollards "deadman") had been installed on the foot path (paving slabs) on the edge of the site boundary which was being cut for the remediation works. As the wind increased the fence and "deadman" blew into the site with the fence panel striking a worker on the shoulder. The worker did not sustain any significant injuries as a result of the incident.

1. Have you considered site hoarding as temporary works?
2. Are your Team trained in Temporary Works?
3. Does your Temporary Works procedure consider independent review and or check?
4. Once installed is there a process to inspect, monitor and record?
