Alert

Outline the Scene	Incident	Cut to finger requiring stitches
	Subject	Contact with sharp objects
	Incident Date	24/02/2026
	Business Unit	Fletcher Living – CentralNorth Region

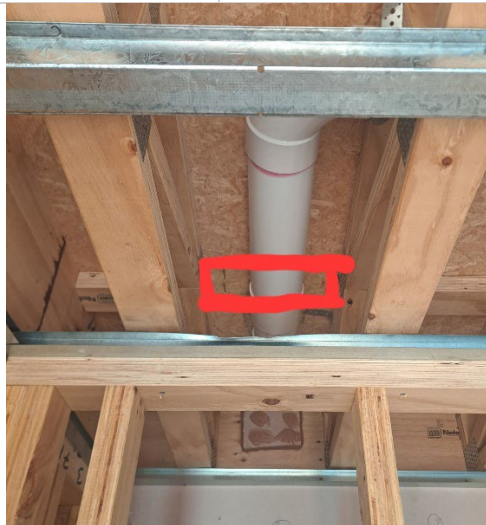
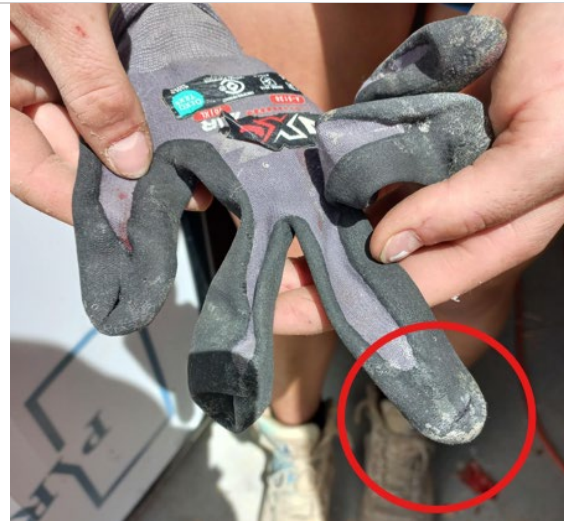
A nog was covering the sheet joint of the flooring, and the IP needed to run the plumbing as close to the floor as possible to achieve sufficient fall. The IP was working in a confined space and, due to the restrictions, chose to use his non-dominant (left) arm to knock out the nog.

While removing the nog between the mid-floor joists with a hammer, the IP struck the nog once, causing it to move slightly. On the second strike, the nog released. The momentum of the strike carried the IP's left hand forward, causing it to come into contact with the Rondo "C" channel attached to the top plate. This resulted in a laceration to the middle finger and a blood blister under the thumbnail. The IP was wearing gloves at the time of the incident. He received stitches, and the blood was drained from his thumb.

- 1) What other method could have been used to remove the nog?
- 2) Was there an alternative way to create the fall required for the plumbing? (e.g., lowering the ceiling)
- 3) Did we consider the risks when using non-dominant hands?
- 4) Was there a safer tool that could have reduced the force or momentum required? (e.g., carpenter's nail bar instead of a hammer)
